**Learning from  
cross-cutting cooperation  
with other industries  
to improve and maintain  
nuclear safety in the EU**

**Summary Report**

ENCO FR-(12)-70

Mai 2013

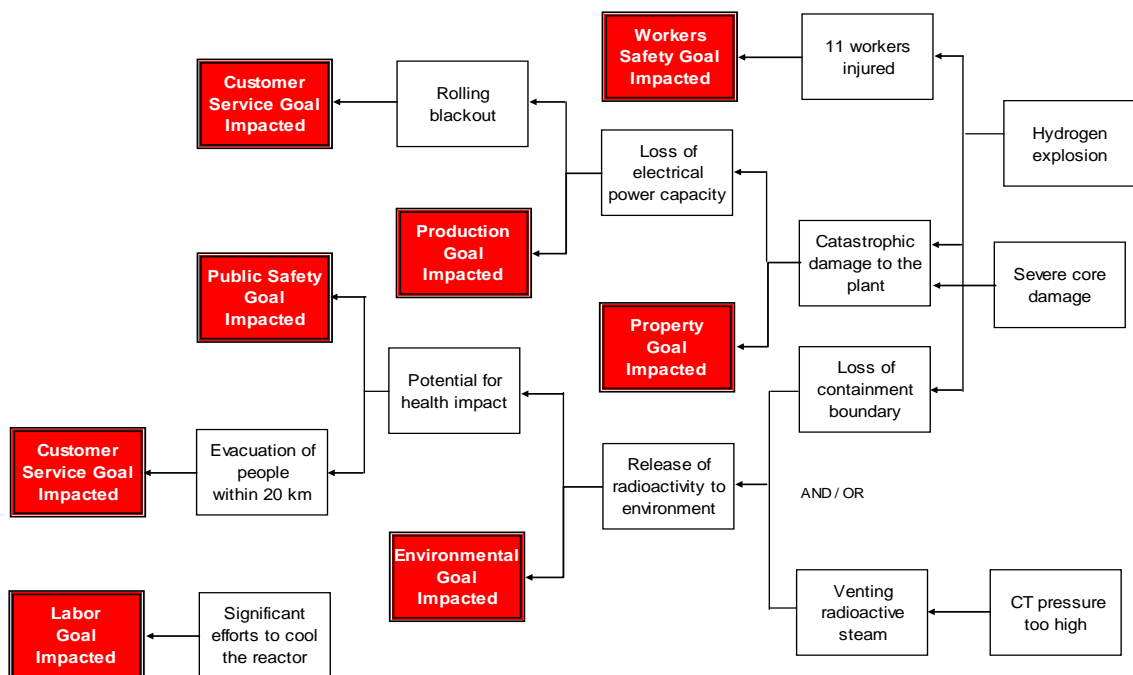
### Step 2. Cause Map - Page 1

Following loss of RCIC and HPCI, the release of steam from the reactor system via SRV was performed by the personnel in an attempt to depressurize the system. Reactor pressure was too high and had to be reduced to allow injection using a fire pump - at this moment the only available means to maintain the reactor vessel water inventory and to prevent uncovering of the reactor core. Depressurization of the reactor system was achieved by releasing steam through the relief

valve that was open manually by the personnel. This action was difficult to achieve due to a high radiation level and the lack of lighting in the plant compartments.

Severe core damage occurred because there was no cooling of the core for a long time. TEPCO estimates that following the loss of high pressure coolant injection (approximately 36 hours after reactor trip) there was no injection into the reactor for 6 hours and 43 minutes. This led to severe overheating and partial melt of the fuel. Residual heat was at a relatively high level as the Unit 3 was under operation at the onset of the event.

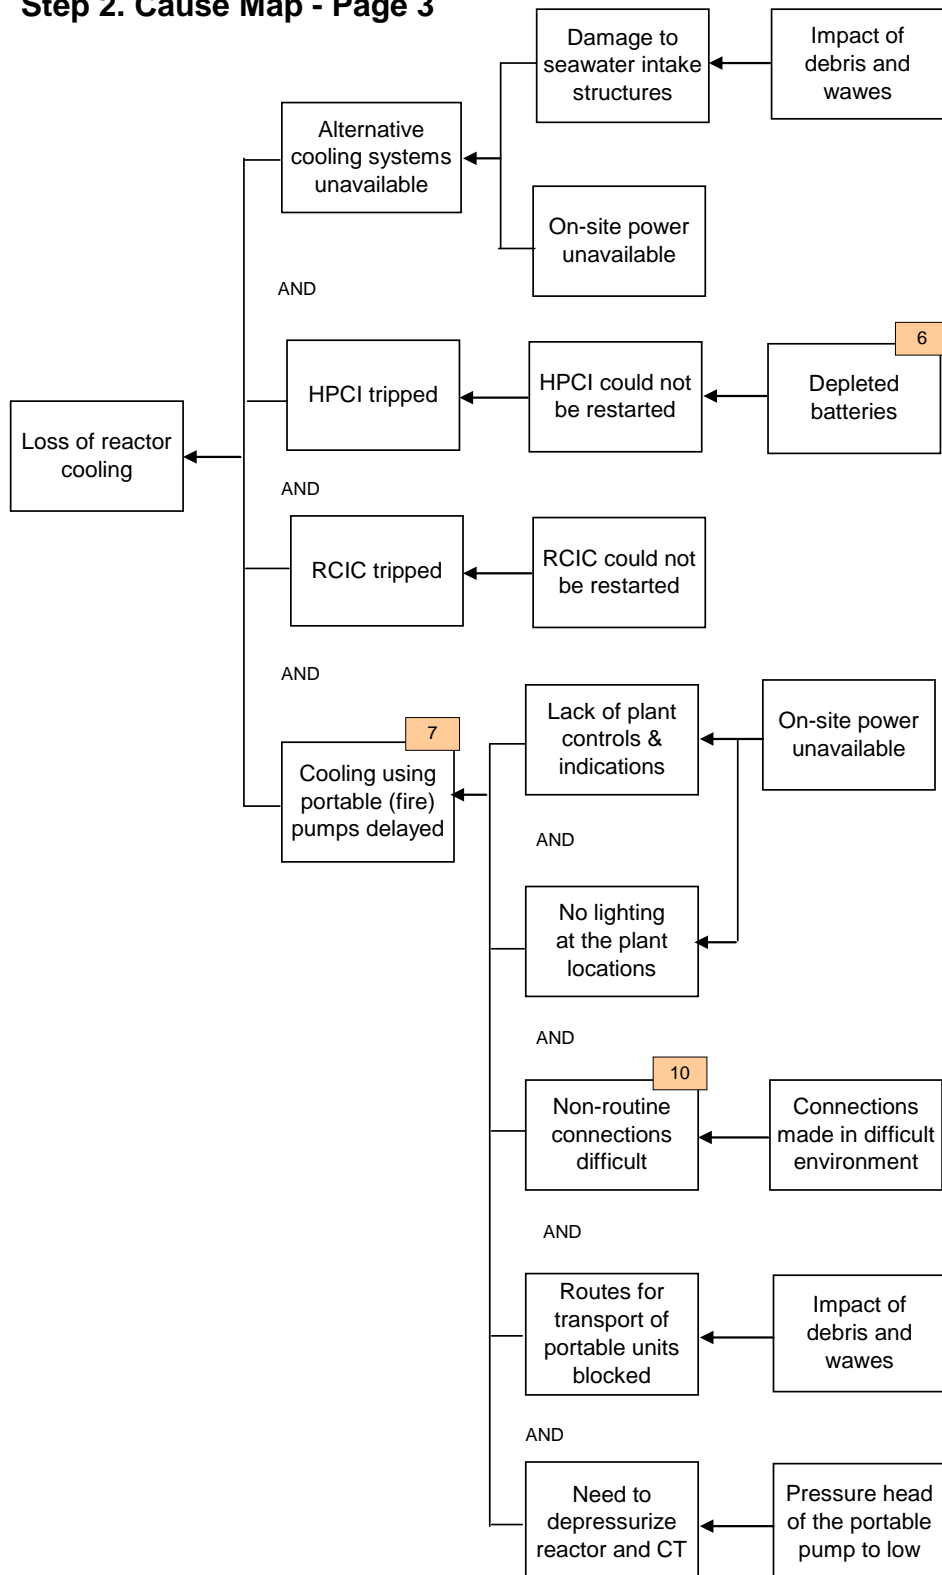
## Step 2. Cause Map - Page 3

Hydrogen explosion in the reactor building was caused by the formation of explosive mixture of hydrogen and air in the reactor building. The lack of core cooling to compensate for decay heat resulted in excessive fuel temperatures and oxidation of the zirconium cladding. The oxidation of

zirconium in a steam environment creates significant additional heat from the exothermic reaction and large quantities of hydrogen. This hydrogen contributed to the increases in containment pressure and to the subsequent hydrogen explosion. The extended duration of high temperature and pressure conditions inside containment may have damaged the drywell head seals, leading to hydrogen leaks and the subsequent explosions.

Loss of reactor cooling was caused by the loss of high pressure emergency core cooling systems HPCI and RCIC. RCIC shut down unexpectedly and could not be restarted. HPCI tripped and could not be restarted due to depleted batteries. Other potential high pressure cooling systems (SLC, CRD) as well as low pressure systems (CS, RHR, RHRS) were non-functional due to loss of AC power as well as the loss of heat sink sources.

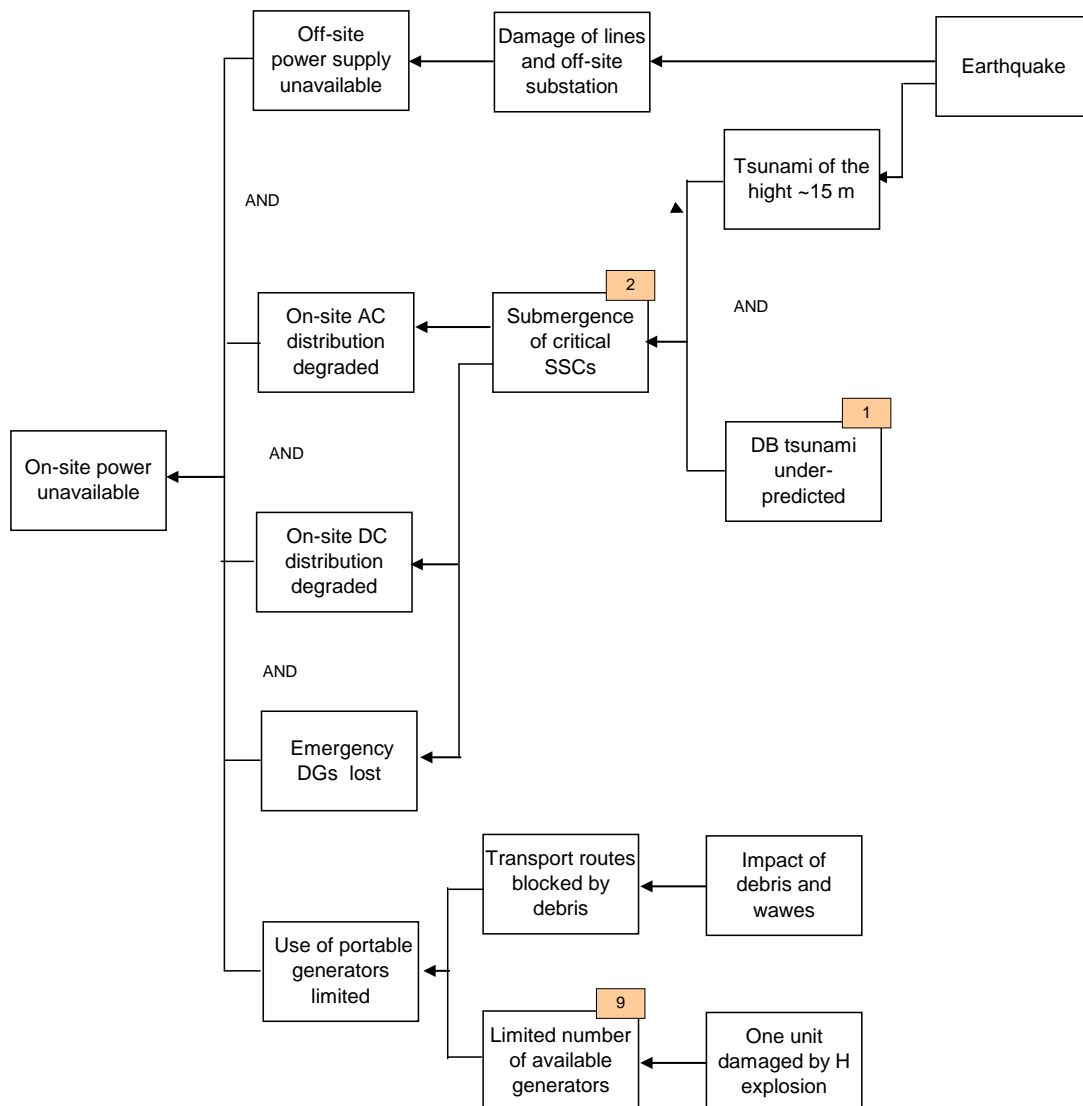
### Step 2. Cause Map - Page 4

There were also problems with using portable fire engines. Out of the three fire engines Fukushima Daiichi had available, one was damaged by the tsunami and a second could not reach units 1-4 because of earthquake damage to the road. Only one fire engine was immediately available to support the emergency response on units 1-4.

Use of this fire engine required non-routine connections that had to be established in a difficult environment (increased temperature, radiation and in darkness). Additional problem, caused by the loss of on-site power, was the lack of indications and controls of valves involved in the implementation of the required lineup.

On-site power was lost because of the loss of off-site power and the loss of emergency diesel generators (EDGs). Off-site power was lost because of earthquake which damaged breakers and distribution towers. Following the earthquake, the on-site power relayed on EDGs which started on loss of offsite power. This source was lost because of tsunami. Tsunami resulted in flooding of both the EDGs and the on-site electrical distribution system (switchgear rooms). Submergence of critical SSCs in the power supply system resulted in the complete loss of AC power and led to a partial loss of DC power. All DC power was lost on units 1 and 2, while some DC power from batteries remained available on Unit 3.

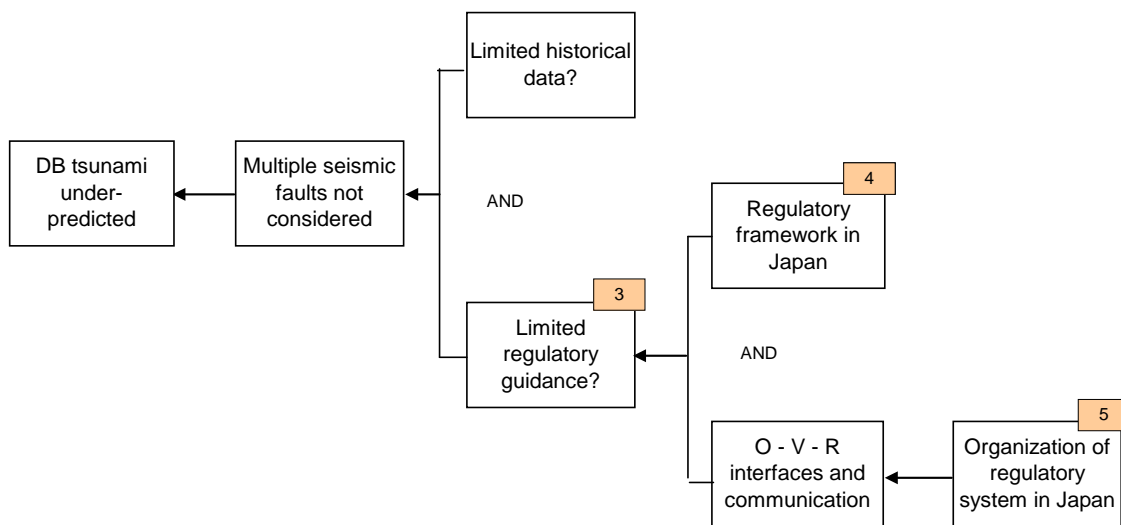
## Step 2. Cause Map - Page 5

Extensive damage of the electrical power supply system at the site was caused by the tsunami impacting the site that exceeded the design basis of the plant. The maximum tsunami height was estimated to be 14 to 15 meters as compared to the design basis tsunami height of 5.7 meters. This was above the site grade levels of 10 meters at units 1- 4. The seawater intake structure was also severely damaged and was rendered nonfunctional.

The tsunami protection strategy for the plant consisted of locating critical equipment, such as vital seawater pump motors, above the elevation of the assessed tsunami height. The assessment of the tsunami height was based on the 2002 Tsunami Assessment Method for Nuclear Power Plants in Japan, the accepted methodology by the Japanese industry. Following the guidance of this methodology, offshore fault segments were not combined in the tsunami assessment. During the

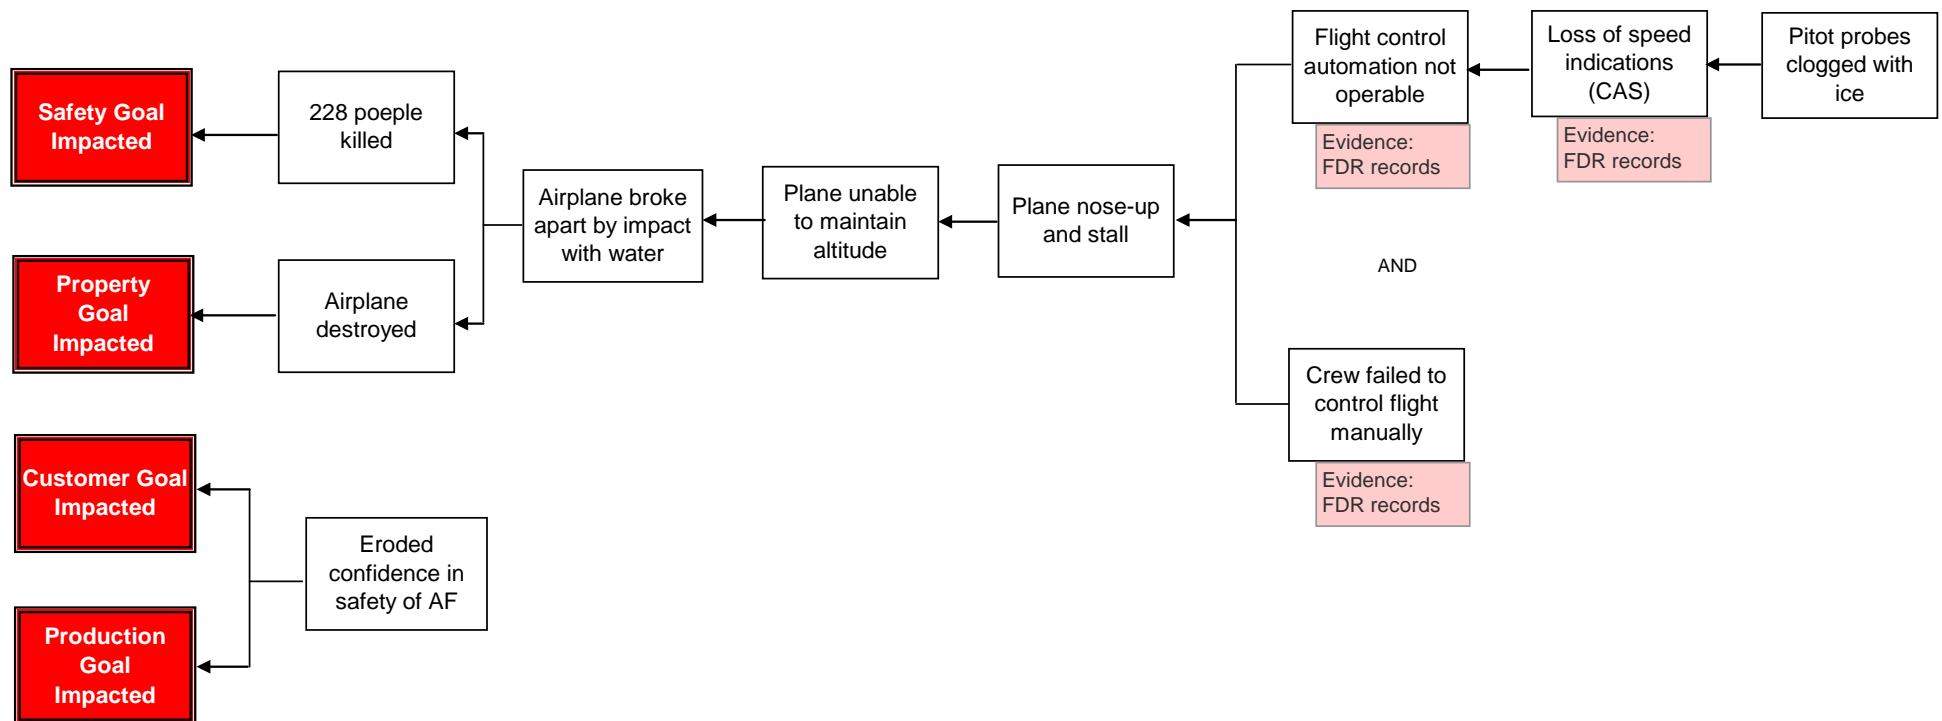
## Step 2. Cause Map - Page 1

Pitot probes problem was caused by the formation of ice inside the pitot tubes, because the plane passed into clouds associated with a large system of thunderstorms. Unlike other planes' crews flying through the region, AF447's flight crew has not changed the route to avoid the worst of the storms. The outside temperature was much warmer than forecast, preventing the still fuel-heavy aircraft from flying higher to avoid the effects of the weather. Instead, it ploughs into a layer of clouds.

The pitot probes on Airbus F-GZCP were produced by a French company, Thales, and the model was known as Thales AA. These Pitot probes were more vulnerable than most other models used currently. In the years leading up to the crash of Flight 447, the Thales AA model was problematic in places where the meteorological conditions like those at Tasil Point.

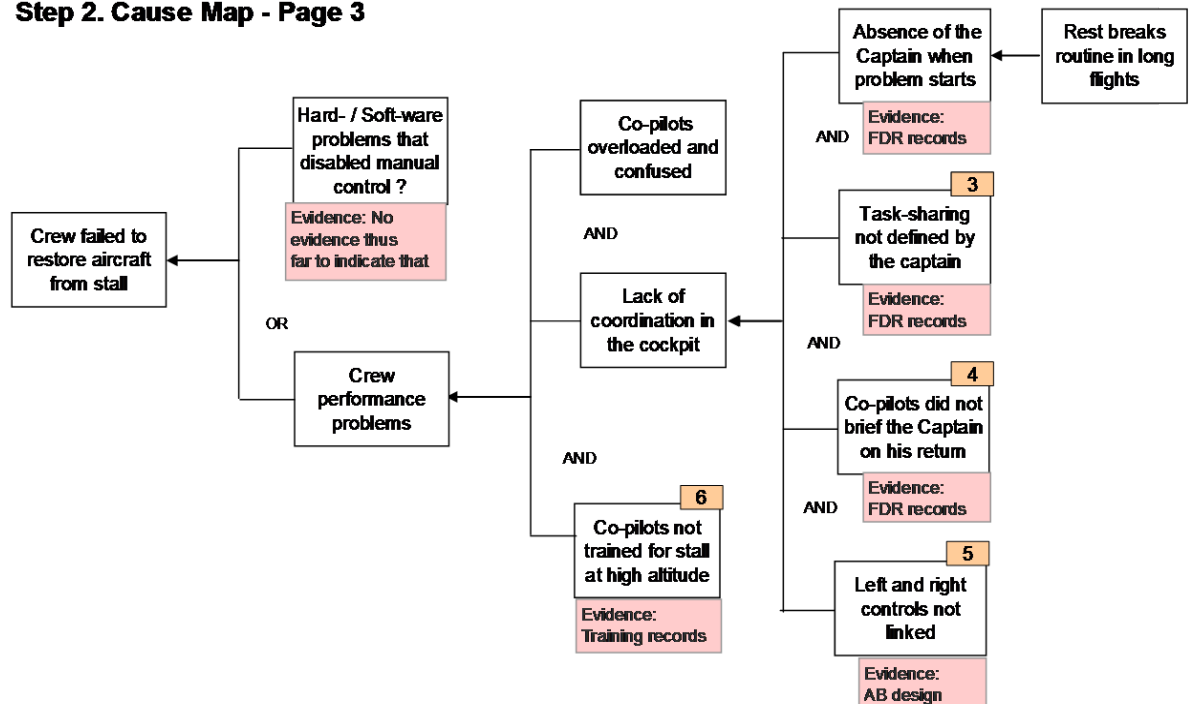
## Step 2. Cause Map - Page 3

Important factor was also the lack of co-ordination in the cockpit. The interaction between the two co-pilots during the moments of crisis demonstrates remarkably poor communication, despite their training in crew resource management. Moreover, there was a marked lack of situational awareness, with everyone focusing on a few small details while ignoring a blaring cockpit alarm, which repeated the word "stall" 75 times before the plane crashed.

This co-ordination issue has even a broader nature. It started with the captain leaving the cockpit to take rest without explicitly clarifying who's in charge when two co-pilots are alone in the cockpit. They are failing, essentially, to cooperate. It is not clear to either one of them who is responsible for what, and who is doing what. In the opinion of Chris Nutter, an airline pilot and flight instructor, this is a natural result of having two co-pilots flying the plane. "When you have a captain and a first officer in the cockpit, it's clear who's in charge," Nutter explains. "The captain has command authority. He's legally responsible for the safety of the flight. When you put two first officers up front, it changes things. You don't have the sort of traditional discipline imposed on the flight deck when you have a captain."

Another important aspect that contributed to the poor co-ordination within the cockpit is that left and right controls are not linked. The side sticks on an Airbus are "asynchronous" - that is, they move independently. "If the person in the right seat is pulling back on the joystick, the person in the left seat doesn't feel it," says Dr. David Esser, a professor of aeronautical science at Embry-Riddle Aeronautical University. "Their stick doesn't move just because the other one does, unlike the old-fashioned mechanical systems like used in small planes, where if you turn one, the [other] one turns the same way." PNF has no idea that, despite their conversation about descending, PF has continued to pull back on the side stick.

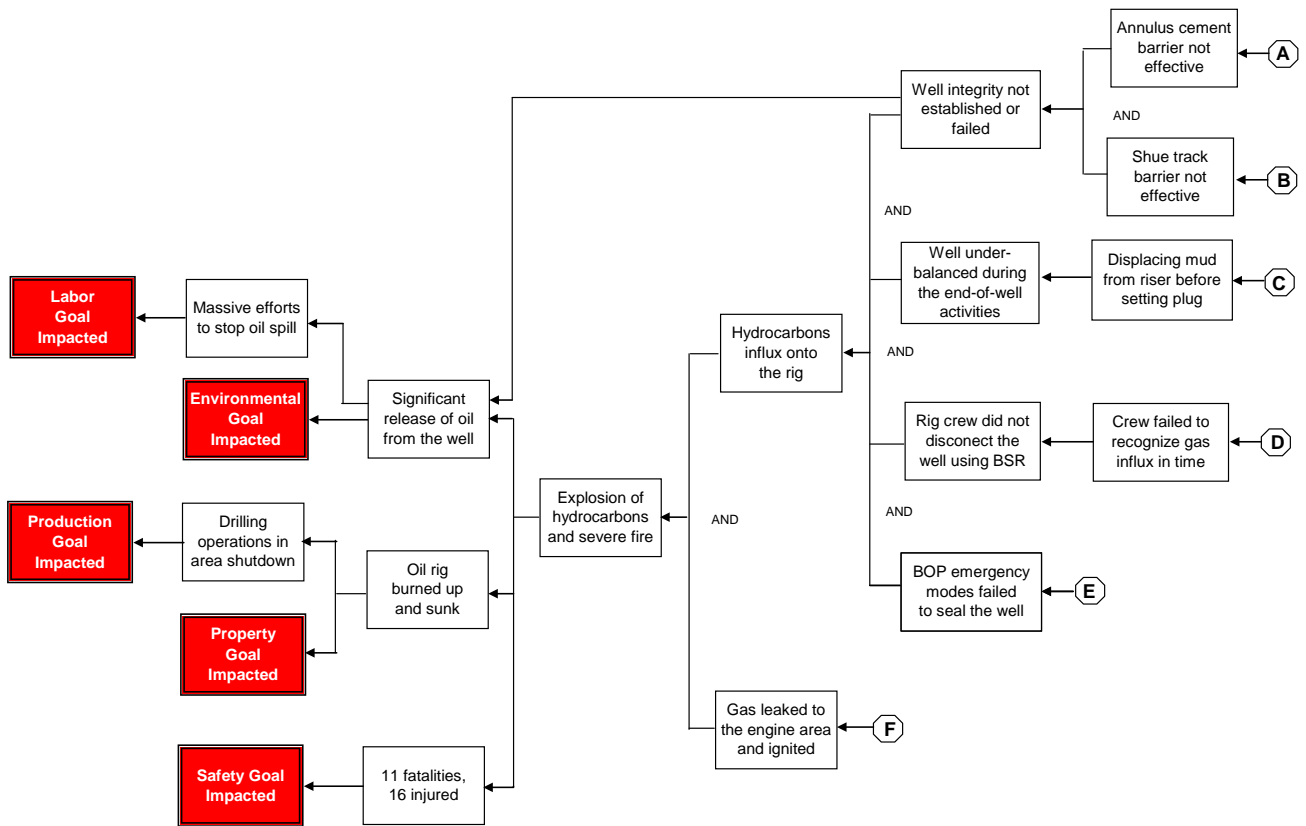
### Step 2. Cause Map - Page 1

Centralizers are critical components in ensuring a good cement job. The evidence to date does not unequivocally establish whether the failure to use 15 additional centralizers was a direct cause of the blowout. But the process by which BP arrived at the decision to use only six centralizers at Macondo illuminates the flaws in BP’s management and design procedures, as well as poor communication between BP and Halliburton.

It does not appear that BP’s team tried to determine before April 15 whether additional centralizers would be needed. Had BP examined the issue earlier, it might have been able to secure additional centralizers of the design it favored. Nor does it appear that BP based its decision on a full examination of all potential risks involved. Instead, the decision appears to have been driven by an aversion to one particular risk: that slip-on centralizers would hang up on other equipment.

BP did not inform Halliburton of the number of centralizers it eventually used, let alone request new modeling to predict the impact of using only six centralizers. Halliburton happened to find out that BP had run only six centralizers when one of its cement engineers overheard a discussion on the rig.

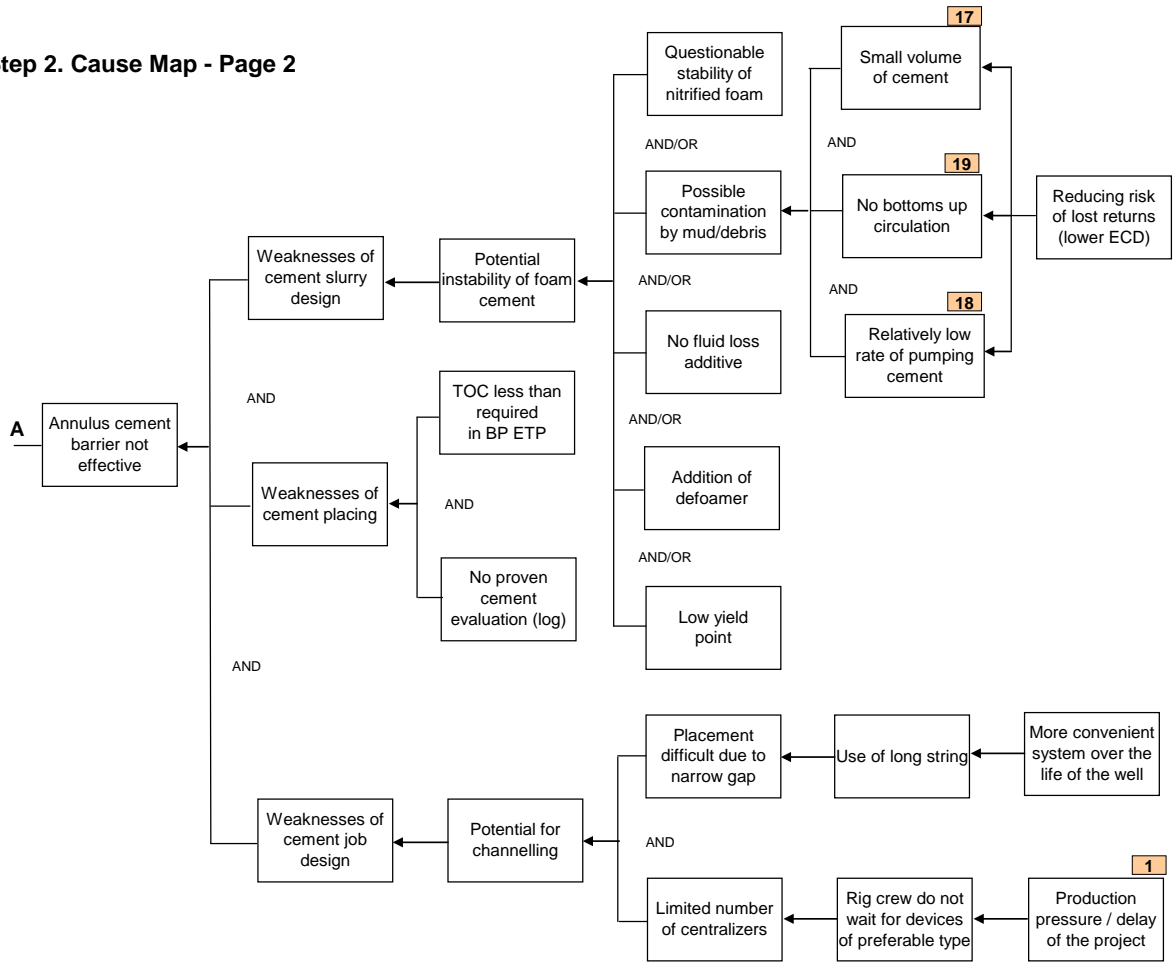
**Step 2. Cause Map - Page 2**

It needs to be noted that the decisions on the use of long casing string, limited number of centralizers, and Top Of Cement (TOC) lower than in BP's Engineering Technical Practice, which had potential impact on the integrity of cement annular barrier, were convenient from the production point of view or intended to save time and money.

The BP team erred by focusing on full returns as the sole criterion for deciding whether to run a cement evaluation log. The BP Macondo team used final lift pressure and returns to confirm successful cement placement and decided no further evaluation was needed. However, this was not in line with procedures which state that more rigorous evaluation is required in some circumstances.

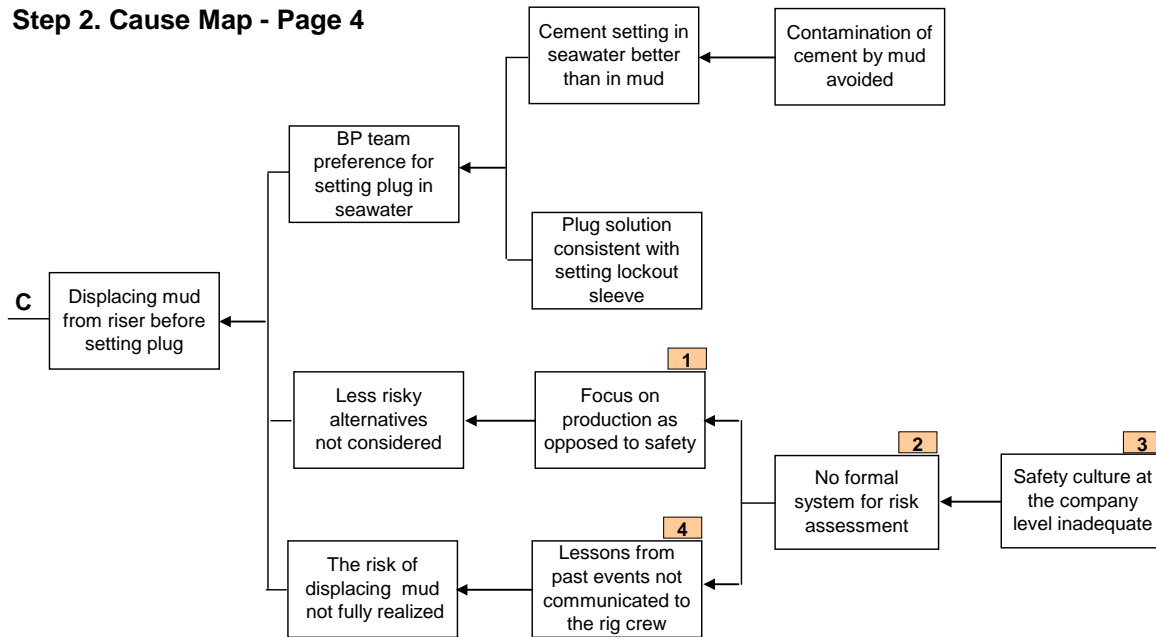
## Step 2. Cause Map - Page 4

It is noted that setting the cement plug 3,300 feet below the mud line was not necessary. The BP Macondo team chose to do so in order to set the lockdown sleeve last in the temporary abandonment sequence to minimize the chances of damage to the sleeve. Setting the lockdown sleeve would require 100,000 pounds of force. The BP Macondo team sought to generate that force by hanging 3,000 feet of drill pipe below the sleeve – hence the desire to set the cement plug 3,000 feet below the mud line.

BP's desire to set the lockdown sleeve last did not justify the risks its decision created. BP could have used other proven means to protect the lockdown sleeve if set earlier in the process. It also did not need 3,000 feet of space to generate 100,000 pounds of force. There were some recommendations of BP experts for setting the plug roughly 1,300 feet below the mud line (using heavier drill pipe), rather than 3,300 feet down. That would have significantly increased the margin of safety for the well.

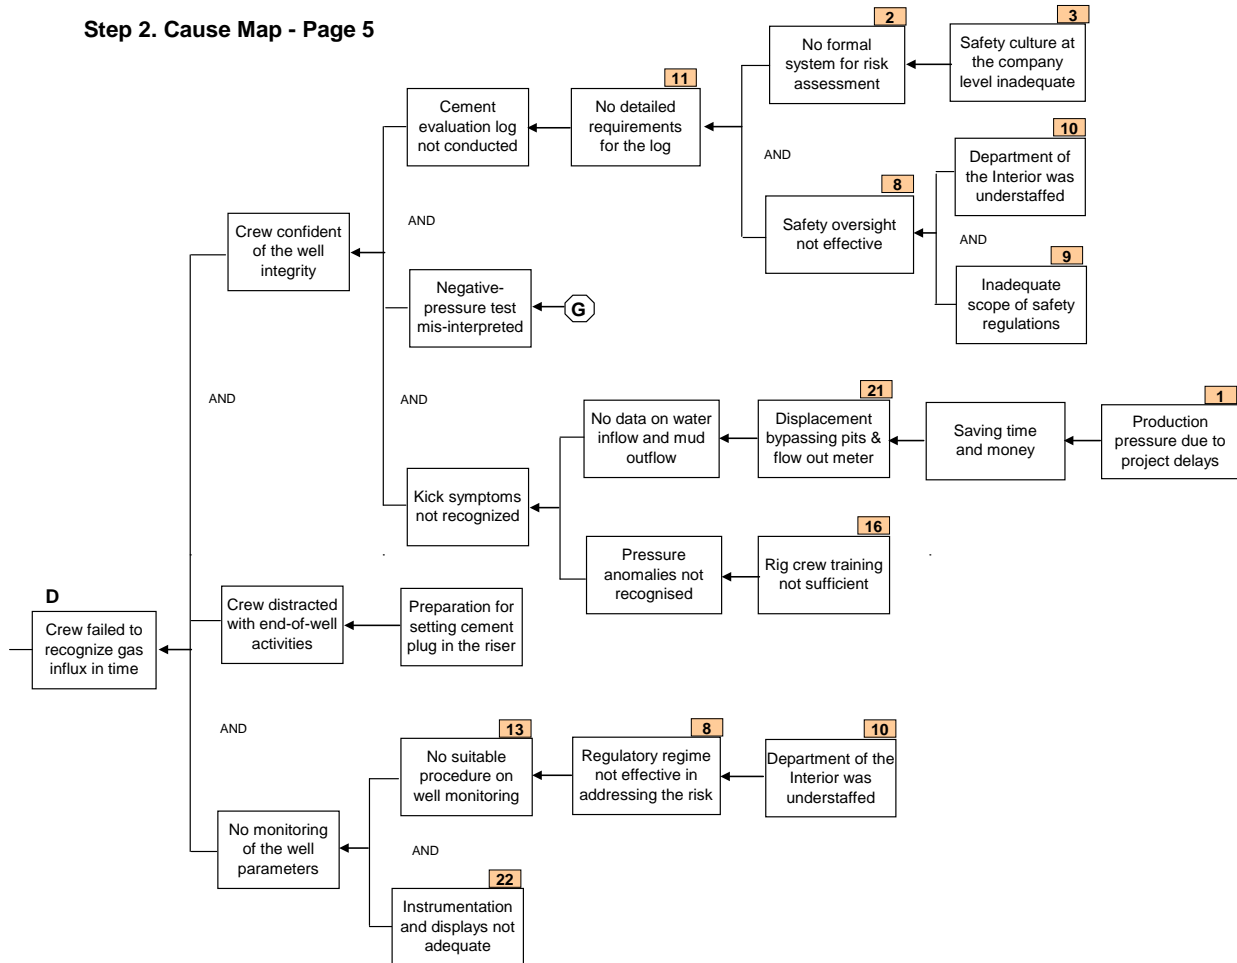
## Step 2. Cause Map - Page 5

If these conditions are not met, as in this case, TOC should be determined by a "*proven cement evaluation log*", which would be done during the completion phase of the well. There is no evidence of a documented risk assessment regarding annulus barriers. It is not clear what is the regulator's position regarding this issue.

There are several potential factors that may have contributed to the failure to properly conduct and interpret the negative pressure test that night.

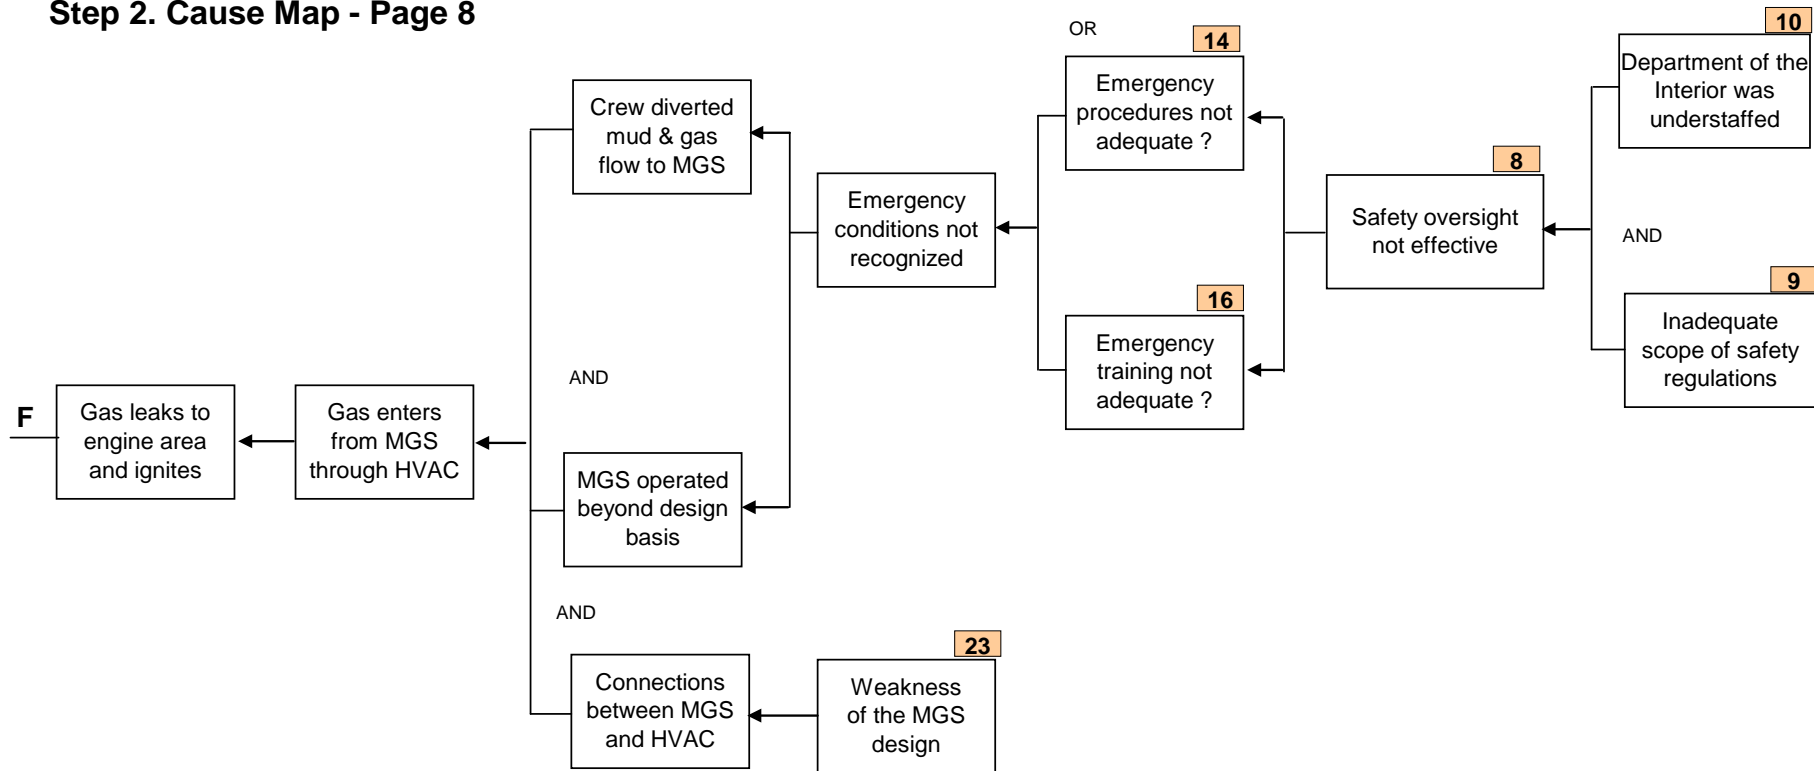
## Step 2. Cause Map - Page 8

It is not clear why personnel did not choose to divert the gas directly overboard. While that ultimately may not have prevented an explosion, diverting overboard would have reduced the risk of ignition of the rising gas. Considering the circumstances, the crew also should have activated the blind shear ram to close in the well. Diverting the flow overboard and/or activating the blind shear ram may not have prevented the explosion, but likely could have given the crew more time and perhaps limited the impact of the explosion.

There are a few possible explanations for why the crew responded in this way. The crew may not have recognized the severity of the situation, though that seems unlikely given the amount of mud that spewed from the rig floor. They did not have much time to act. The explosion occurred roughly six to eight minutes after mud first emerged onto the rig floor.
