**Learning from  
cross-cutting cooperation  
with other industries  
to improve and maintain  
nuclear safety in the EU**

**Summary Report**

ENCO FR-(12)-70

Mai 2013

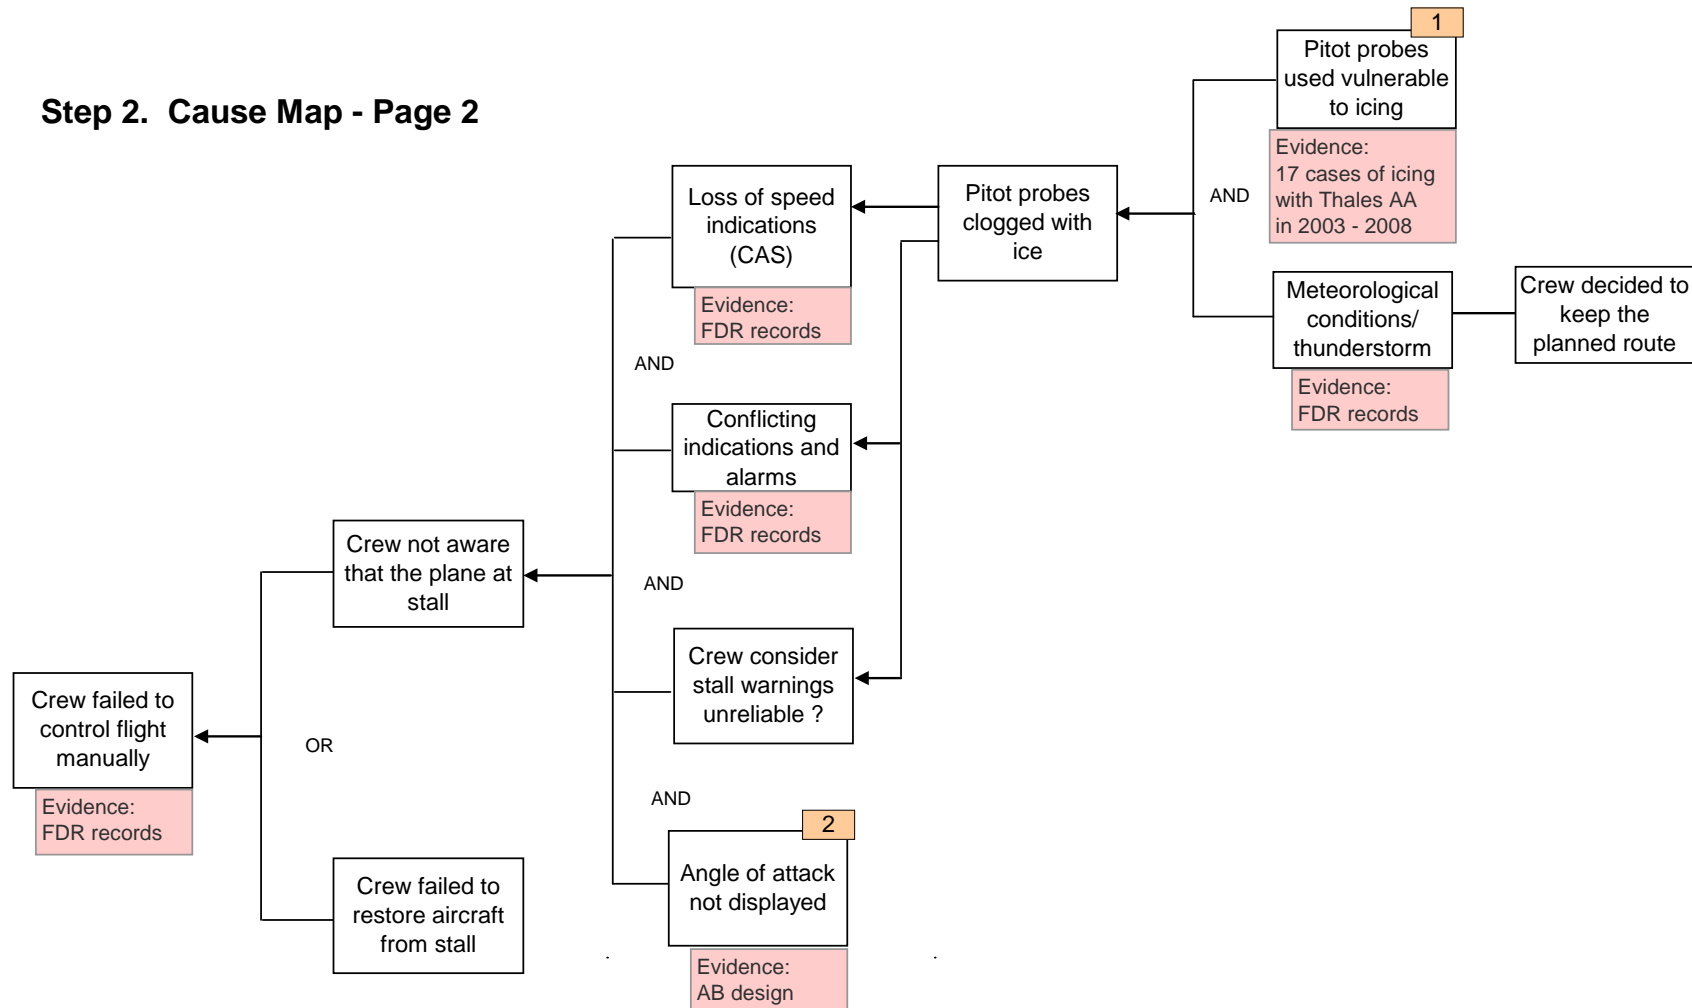
## Step 2. Cause Map - Page 3

Pitot probes problem was caused by the formation of ice inside the pitot tubes, because the plane passed into clouds associated with a large system of thunderstorms. Unlike other planes' crews flying through the region, AF447's flight crew has not changed the route to avoid the worst of the storms. The outside temperature was much warmer than forecast, preventing the still fuel-heavy aircraft from flying higher to avoid the effects of the weather. Instead, it ploughs into a layer of clouds.

The pitot probes on Airbus F-GZCP were produced by a French company, Thales, and the model was known as Thales AA. These Pitot probes were more vulnerable than most other models used currently. In the years leading up to the crash of Flight 447, the Thales AA model was problematic in places where the meteorological conditions like those at Tasil Point.

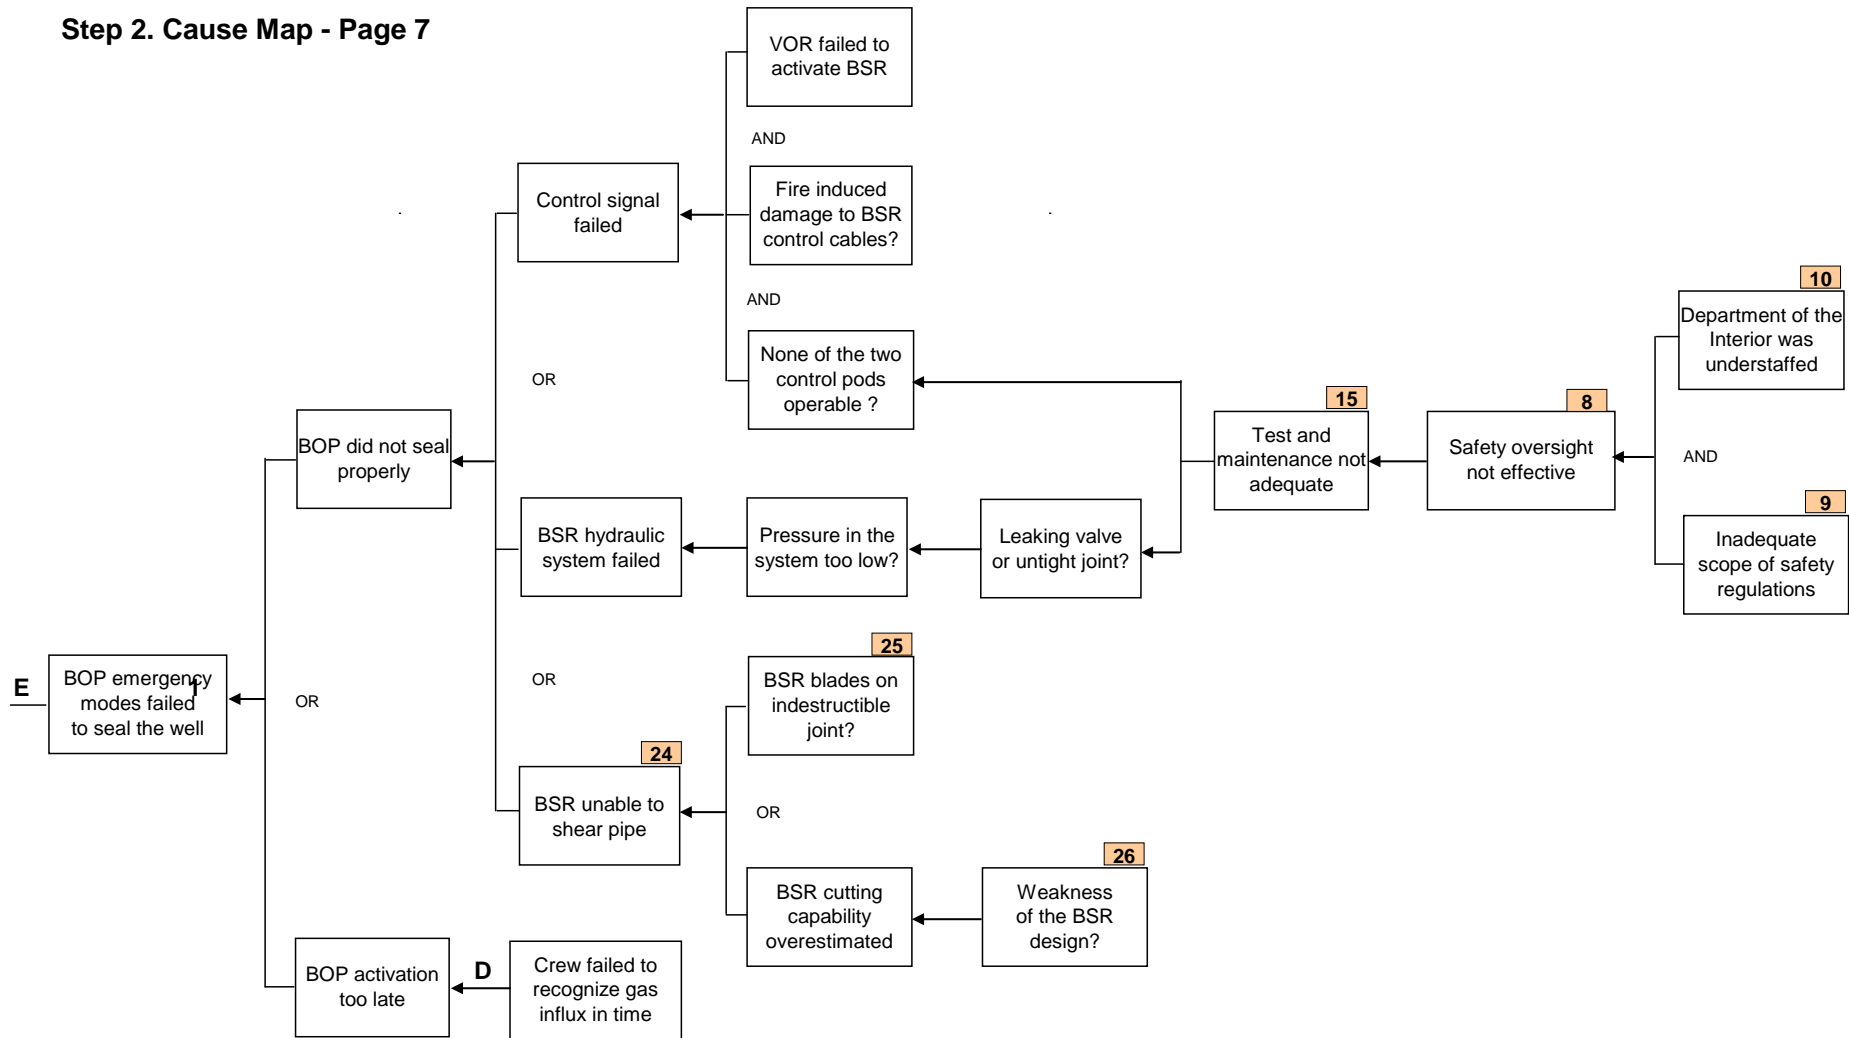
## Step 2. Cause Map - Page 7

When hydrocarbons flow was finally noted, the Deepwater Horizon crew closed the blowout preventer and diverter, routing oil and gas to the mud gas separator (MGS) system rather than diverting it overboard. The MGS was operated beyond design basis and was overwhelmed by the force of oil and gas which leaked into the rig's ventilation system. Gas was exiting the vents located on the derrick, directly above the rig floor.
